**Estudo de azulejos do século XIX e
desenvolvimento de réplicas**

**Study of 19th century wall tiles for technical replicas
development**

Tese apresentada à Universidade de Aveiro para cumprimento dos requisitos necessários à obtenção de grau de Doutor em Engenharia Civil, realizada sob a orientação científica da Doutora Ana Luísa Lomelino Velosa, Professora Auxiliar do Departamento de Engenharia Civil da Universidade de Aveiro e coorientação do Doutor Paulo Barreto Cachim, Professor Associado do Departamento de Engenharia Civil da Universidade de Aveiro e do Doutor João Paulo Coroadó, Professor Coordenador do Instituto Politécnico de Tomar.

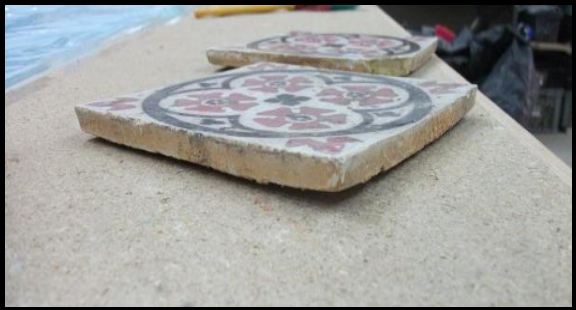
Production defects		
Ceramic body bending	The ceramic body is not completely flat presenting bending due to production problems (pressing, drying or glaze tensioned)

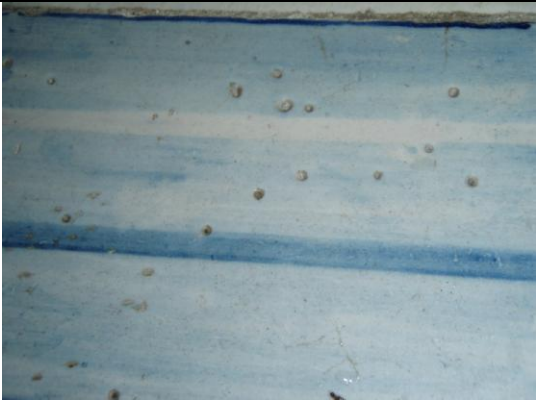
Crater	Very big pin holes and less numerous

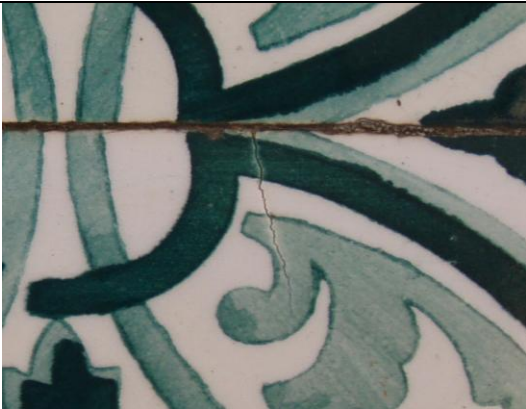
Crack	Ceramic body separation. Pressing, drying or firing defect.

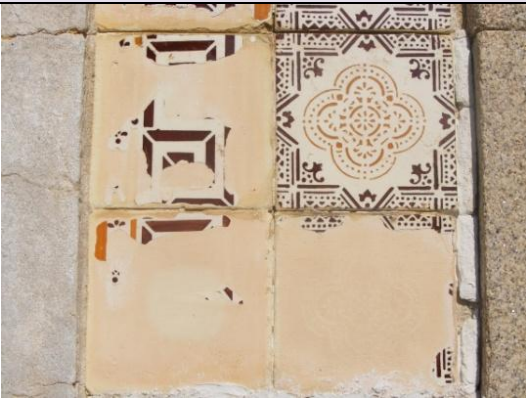
Panel defects		
Glaze detachment	The glaze comes out leaving the ceramic body exposed

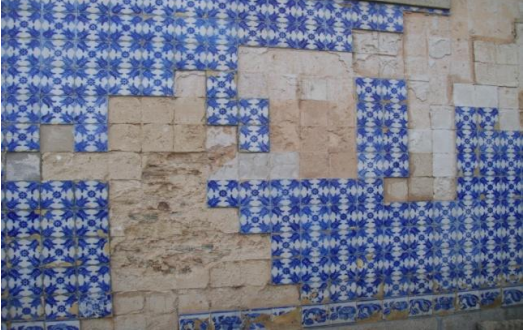
Tile lacunae	Tiles fell down after tile detachment

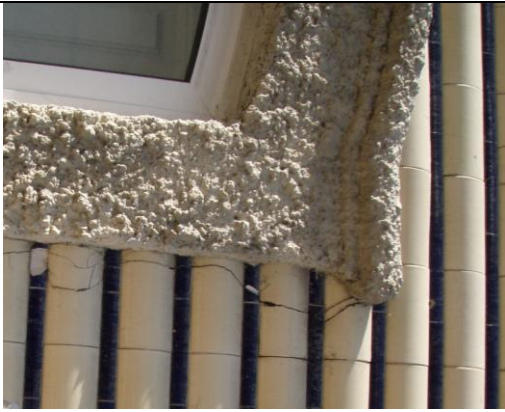
Structural crack	Cracks on the tiles provoked by the building structural movements

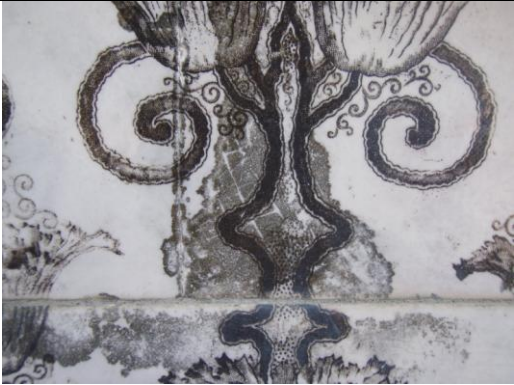
Staining	Stains promoted by the presence of micro-organisms that lie under the transparent glaze

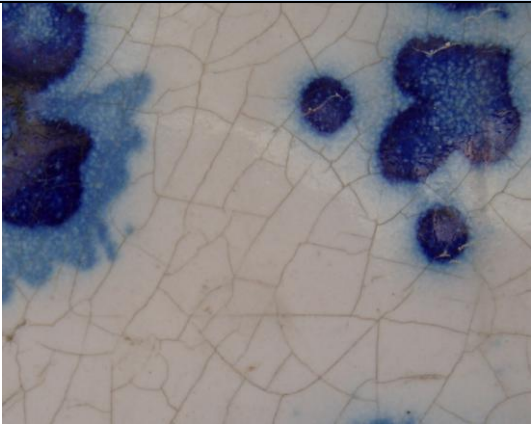
Mix Factors		
Glaze crazing	The glaze cracks due to stresses between the glaze and the ceramic body. This can be due to a bad thermal expansion coefficient agreement between them or by moisture expansion of the ceramic body.

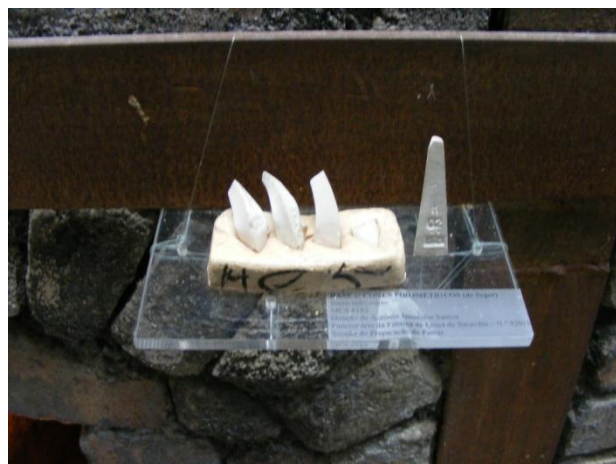
Figure 21 – The remaining of a cone firing control (author’ photo)

Since ancient times the maximum firing temperature control was made visually, being the master consulted to verify the colour of refractory material or colour inside the kiln, using the “colour and brilliance pyrometer” experience of radiation of the materials under the heat of the flames. Later, in a technological giant step, pyrometric cones were invented by Josiah Wedgwood (England) in 1782. But it was Hermann Mow in 1886 that developed the cones bringing them up to the modern era. Its marketing must have begun around 1896. The cone consists of ceramic material the composition of which defines the softening temperature of each cone (each cone has a number associated with its softening temperature). The cones do not give a firing temperature, but the time integration with the temperature, the so-called equivalent temperature. Three to four cones with different softening temperature were placed together in a support (Figures 21 and 22) and placed in a kiln entrance for easy visualization. With the flexion of the right cone, the combustion material was suspended as firing reached the maximum temperature. The kiln temperature would be considered as being the one between the cone less flexed and the one that remained standing.

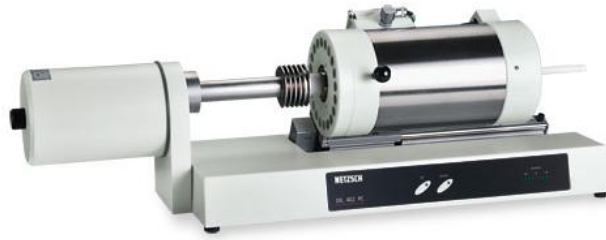
Figure 41 - Netzsch- DIL 402 PC dilatometer (GmbH 2005)

The samples of the ancient ceramic bodies were cut to 25 mm long and 5 mm thick stripes and were submitted to a heating rate of 10°/ min from 30° until 400° C. Calculations were performed by the apparatus software.

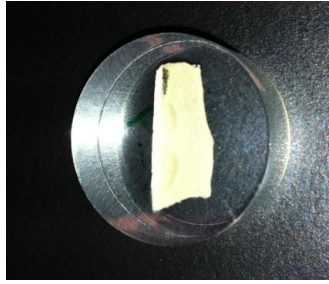
Figure 43 – Resin mounted sample for surface polishing

To enable the visualization of glaze/ceramic body interface, vertical cuts with 1.5 cm length and 0.5 cm height were made in the tile with a sharp mechanical cutting machine, obtaining the simultaneous observation of the glaze, glaze/ceramic body interface and ceramic body. The samples were mounted in resin (Figure 43) and polished with 30, 15, 9, 6, 3 and 1 μm diamond pulp until a smooth surface was obtained. Due to the fact that samples of ceramic body suffer easy degradation in the polishing process, in some samples it was not possible to obtain an even surface.

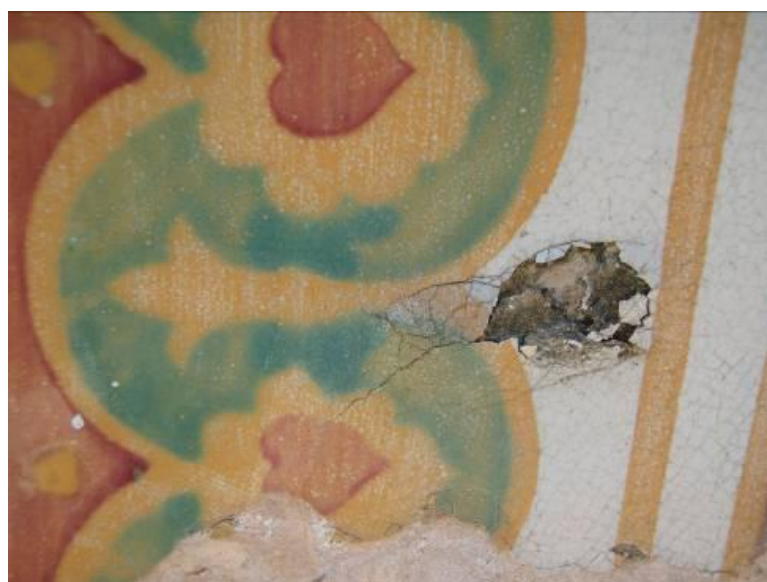
Figure 80 – Example or glaze crazing provoked by persistent humidity (author' photos)

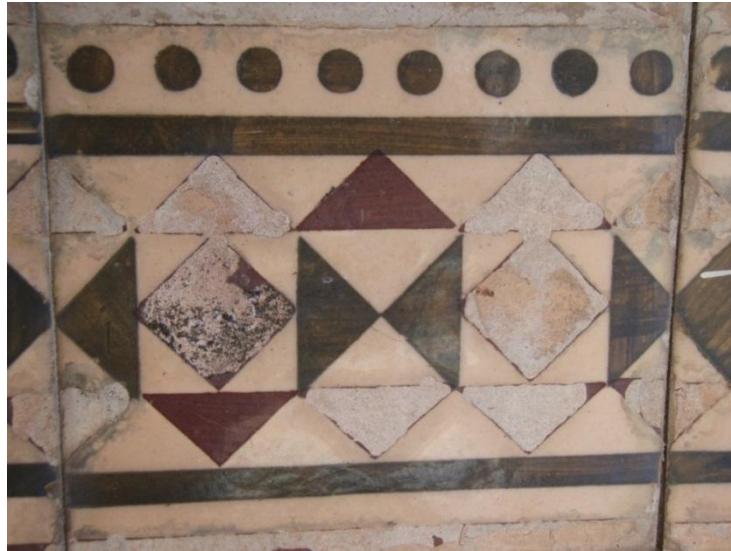
Figure 81 - Colour detachment due to a poor colour/glaze thermal expansion coefficient adjustment (author' photos)

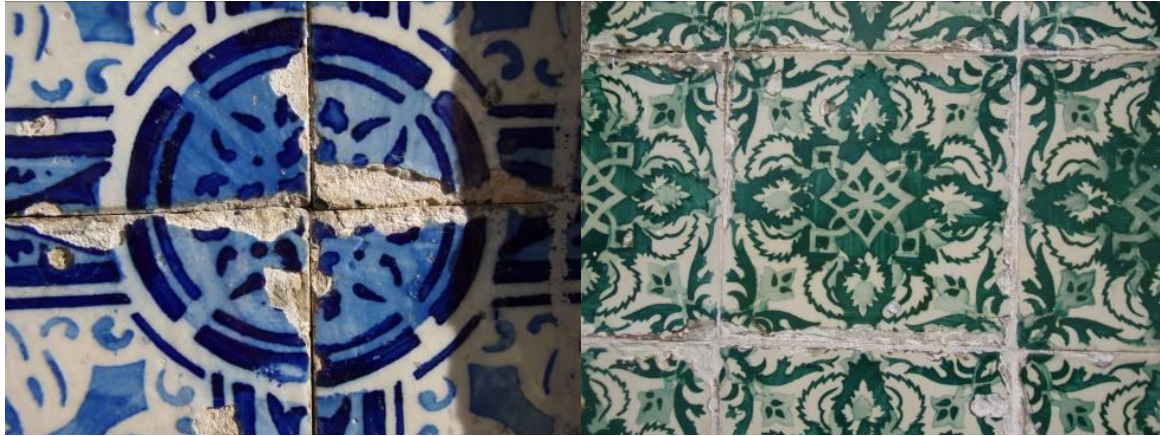
Figure 82– Examples of tile perimeter glaze detachment (author’ photos)

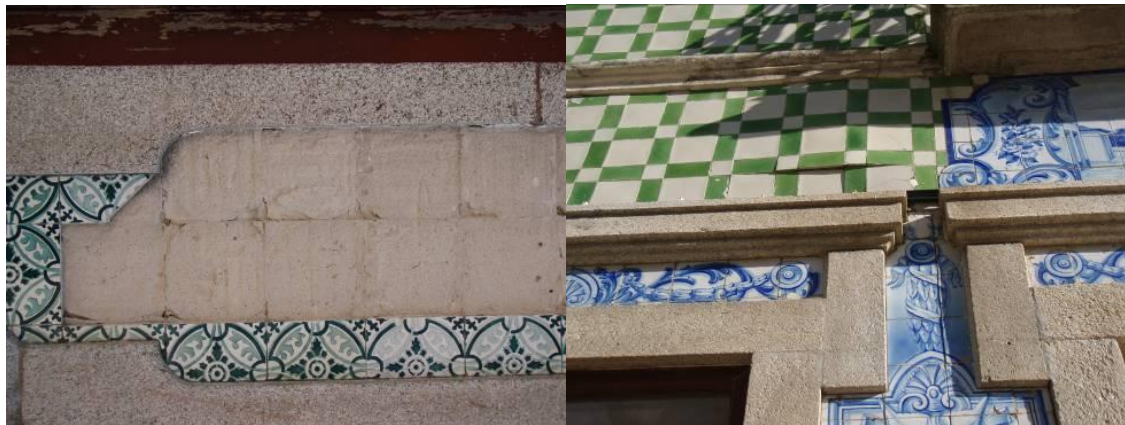
Figure 83 – Examples of lack of mortar/tile adherence (author’ photos)

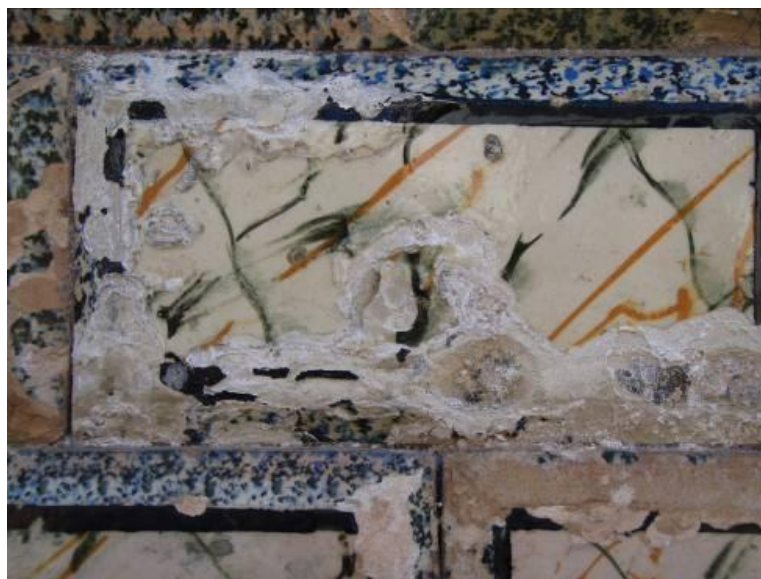
Figure 84 – Example of glaze detachment caused by salt crystallization (author's photos)

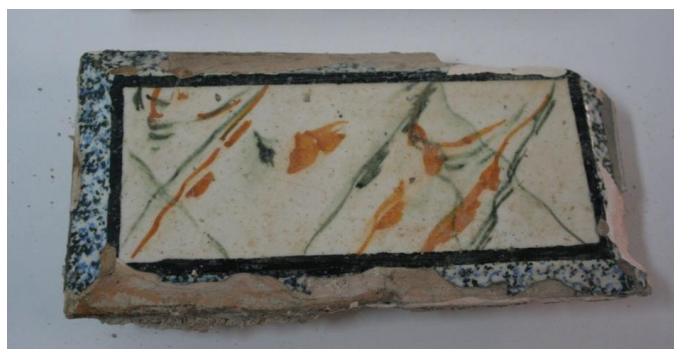
Figure 90 - Glaze detachment in the tile borders caused by salt crystallization.
